CITY OF UNION GAP

**PROJECT MANAGEMENT SERVICES
FOR CITY OF UNION GAP FACILITIES**

**PHASE 1—INFORMATION SPACE
AND
SITE PLAN**

December 31, 2013

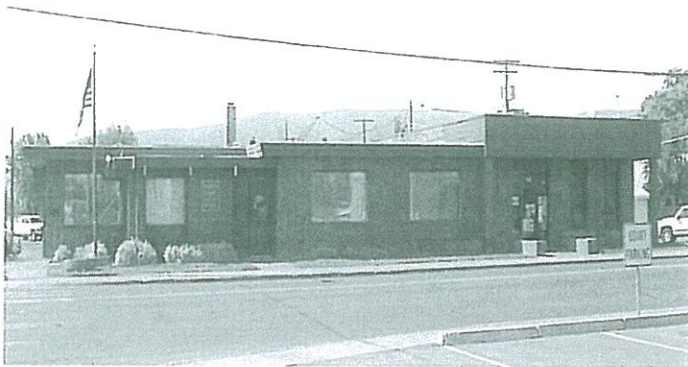
102 W. Ahtanum Road

Facility Description: The existing building is approximately 9,100 sq. ft. in size and located on a site roughly 6/10ths of an acre in size. Surrounding City Hall is off-street parking for roughly 70-vehicles and street side parking for 8 additional vehicles. An additional lot shared with Fire Station 85 has parking for 28 vehicles. Approximately 5,300 sq. ft. of the building is devoted to City administrative offices, the Council Chambers/Courtroom is 1,400 sq. ft. in size and the Library is roughly 2,400 sq. ft. in size. Original portions of the structure date back to 1953.

The building was substantially enlarged and remodeled in 1968. In 1987 and again in 1996 various portions of the building were remodeled to adapt it to changing needs. Specialized elements of the building include a walk-in safe with concrete floors, walls, and a roof. The City has been seeking to acquire all lands in the one block area of City Hall. The City owns all parcels except 3 but has an offer of purchase on 2 out of the 3 remaining lots.

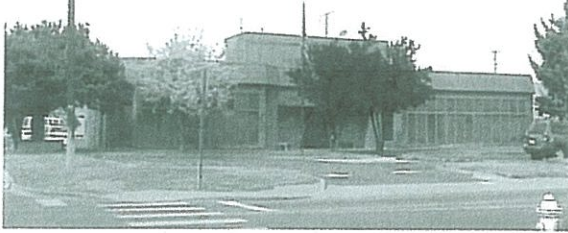
Police Headquarters

Facility Description: This facility was purchased by the City in 1995. It was originally constructed as a branch bank in 1977 but was subsequently used as offices for a variety of businesses prior to purchase by the City. The building is located on an approximately ½ acre site with parking for 34-vehicles. It is roughly 3,800 sq. ft. in size and in fair to good condition. All office space is located on the ground floor. Restroom facilities are located off of the lobby of the building and shared with the public. There are no shower or decontamination facilities in the building.

Analysis: Since acquisition of the building police department staffing has increased by approximately 50-percent. The department now lacks adequate space for administrative, supervisory, and clerical personnel as well as support space for officers. In recent years the workforce of the department has

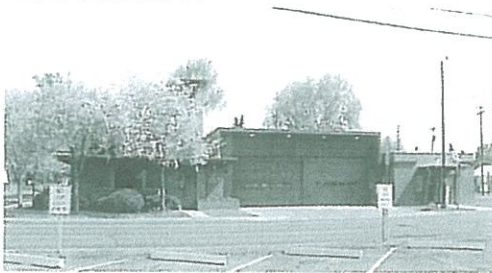
**Fire Department
Fire Station 85**

The existing building is approximately 6,000 square feet in size and is located on a site approximately 2/3rd of an acre in size. It consists of a 4-bay apparatus room together with a fire hose drying tower, approximately 1,500 square feet of administrative offices, and a training and sleeper area roughly 2,250 square feet in size. The training, apparatus room and sleeper area were constructed in 1968, while the administrative offices were added in 1996.

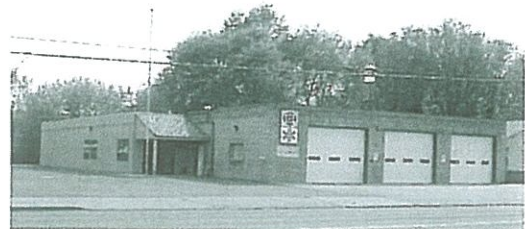
Fire Station 86

The Fire Department currently leases a fire station owned by Yakima County Fire District 11. This district exists only as a taxing entity and contracts to the City of Union Gap for fire services. This station is not normally staffed and is used for equipment storage and as an auxiliary meeting and training facility.

Analysis: Both buildings are in good structural condition but are considered functionally obsolete and undersized. The current level of fire department staffing does not allow for simultaneous operations. If Union Gap is to continue with a separate and autonomous fire department, a new consolidated facility is needed. The facility should be located more central to the city limits as they currently exist on a site roughly 5-acres in size to accommodate a full range of training.

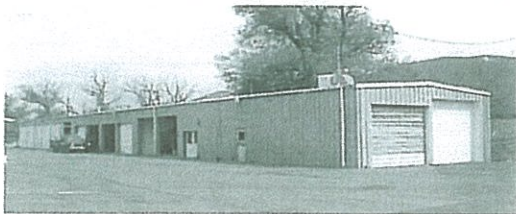
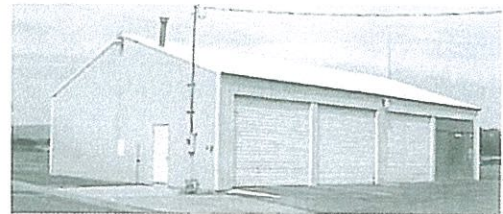
The public works shops are located on a site roughly 8-acres in size. There are two principal buildings supporting the public works activities and several smaller accessory buildings. The site and buildings mostly support the sewer, water, and road departments.

This first building has an overall area of roughly 6,560 sq. ft. and measures 32-feet in depth and 205 feet in length. The original portion of the building was constructed in 1969, with a substantial addition in 1986. The building has an area for equipment and vehicle maintenance together with material, equipment, and

vehicular storage. The second building has an overall area of 2,240 sq. ft. and measures 40-feet in depth and 56-feet in width. This building has an office for the working foreman together with a break/meeting room plus vehicular and equipment storage. Heated indoor storage is essential for many pieces of equipment. Some of the equipment includes water tanks, valves, and piping subject to freeze damage. During winter weather sanding trucks must be stored in a heated space to maintain operational readiness otherwise the fine sand/gravel becomes moisture laden and freezes solid. Roughly 5-acres of the site is devoted to outdoor storage for sand, gravel, sewer and water pipe, valves and miscellaneous equipment.
